NBS TECHNICAL NOTE 1134

Guidelines for the Installation of Solar Components on Low-Sloped Roofs

Guidelines were prepared for the installation of solar collectors and related equipment on low-sloped roofs of commercial and industrial type buildings. The guidelines are concerned primarily with the waterproofing integrity of the roofing system, access to the collectors and roofing, attachment of different types of collector support frames, and safety. Technical information from the literature, building codes, roofing field surveys and acceptable roofing practice provided the basis for the guidelines. The guidelines include recommendations for the design of the solar installation with regard to roofing performance, workmanship during collector installation, and maintenance of roofs with solar components.

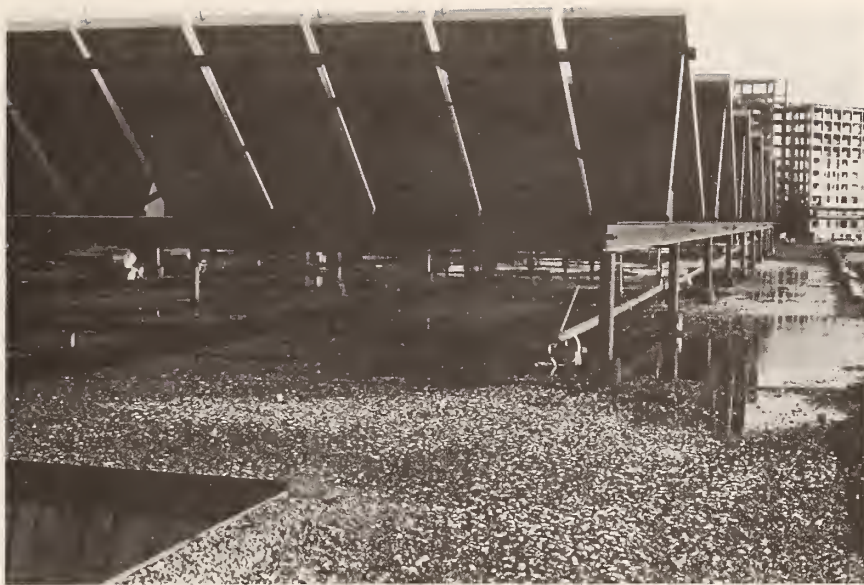
Figure C.1 Ponded Water Under Solar Collectors

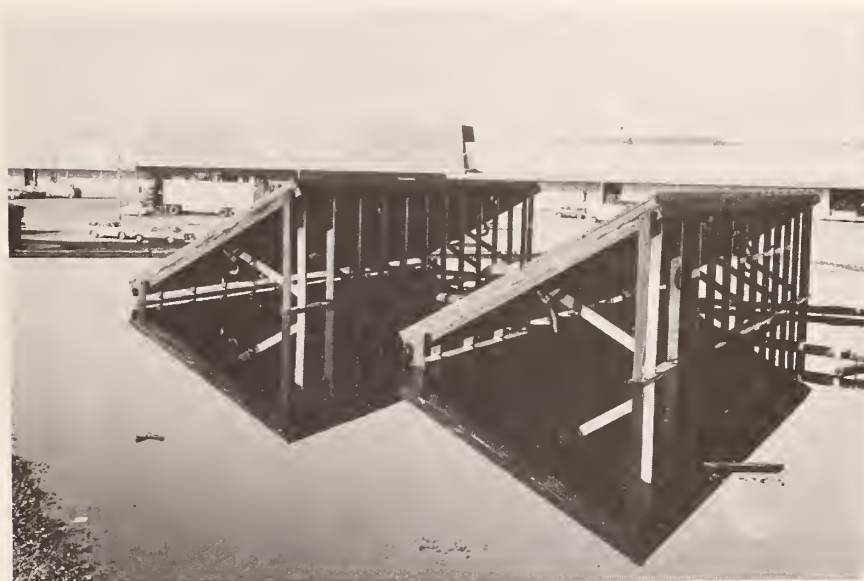
Figure C.2 Ponded Water Over 2 inches (50 mm)
Deep Around Collectors

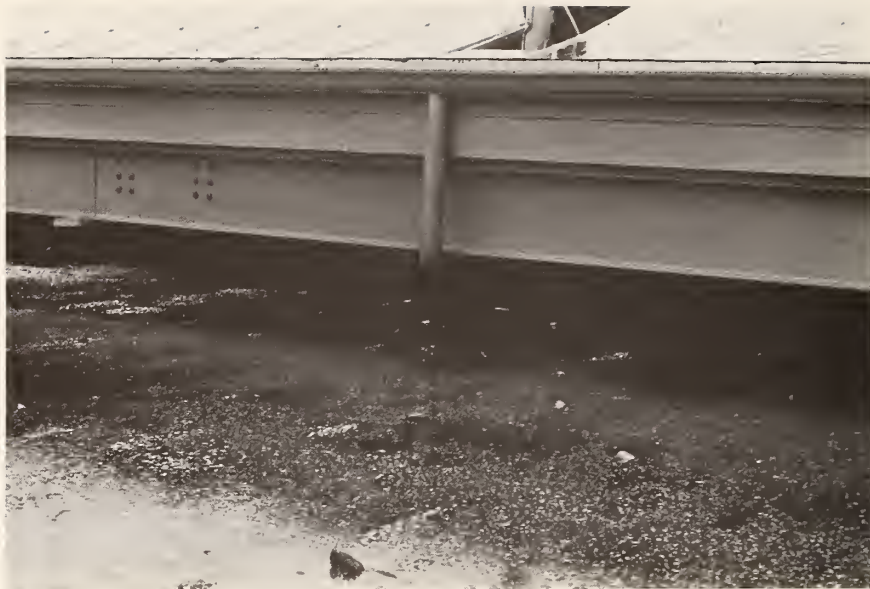
Figure C.3 Ponded Water on Roof Surface Extending Under Large Wooden Platform Supporting Solar Reflectors

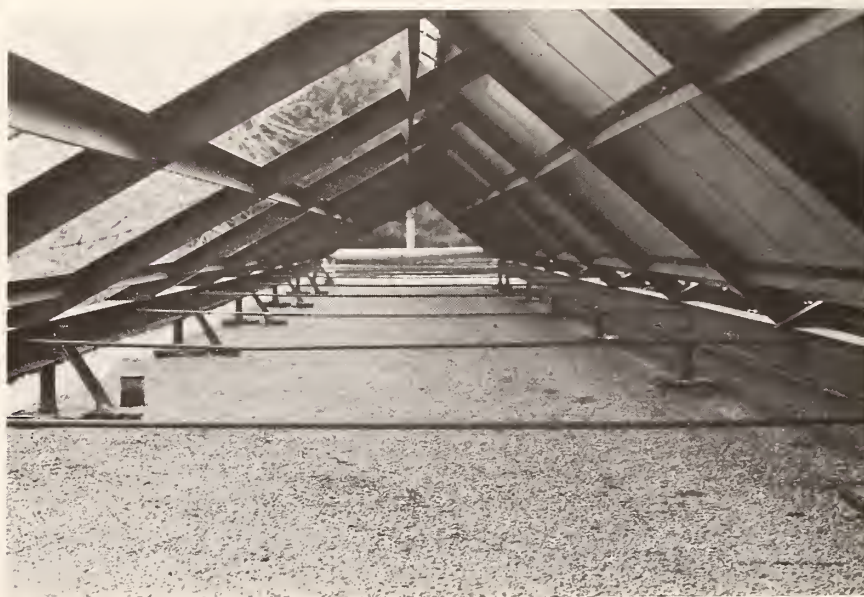
Figure C.4 Steel Columns Extending Through Roofing Support Collector Frames

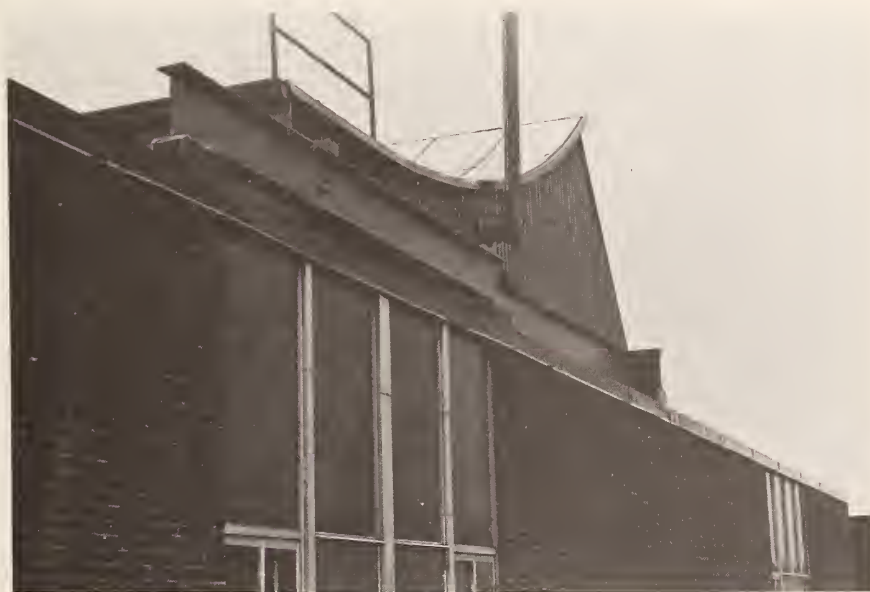
Figure C.6 Large Wooden Reflector Frame Supported by Exterior Walls and Columns of the Building

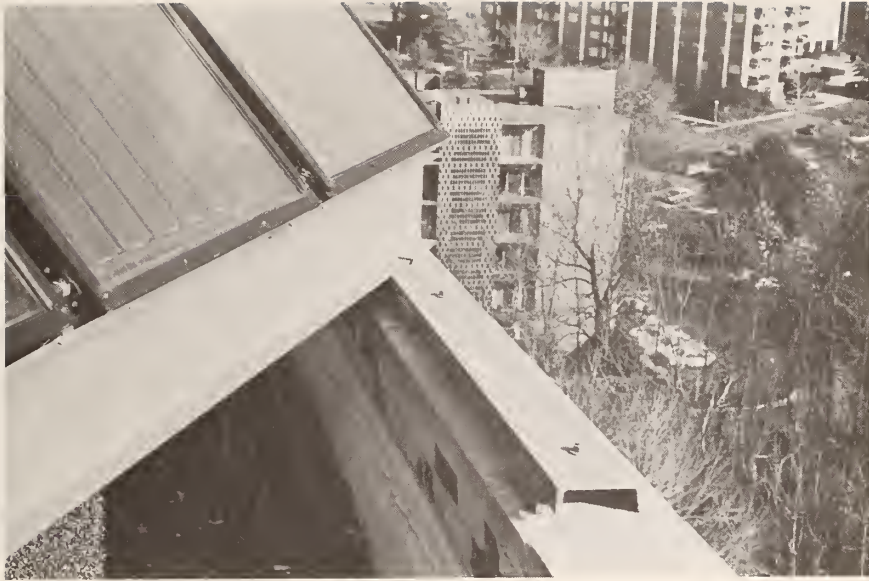
Figure C.9 Attachment of Collector Support Beam Using a Steel Clip Welded to a Channel which is Bolted to a Parapet Wall

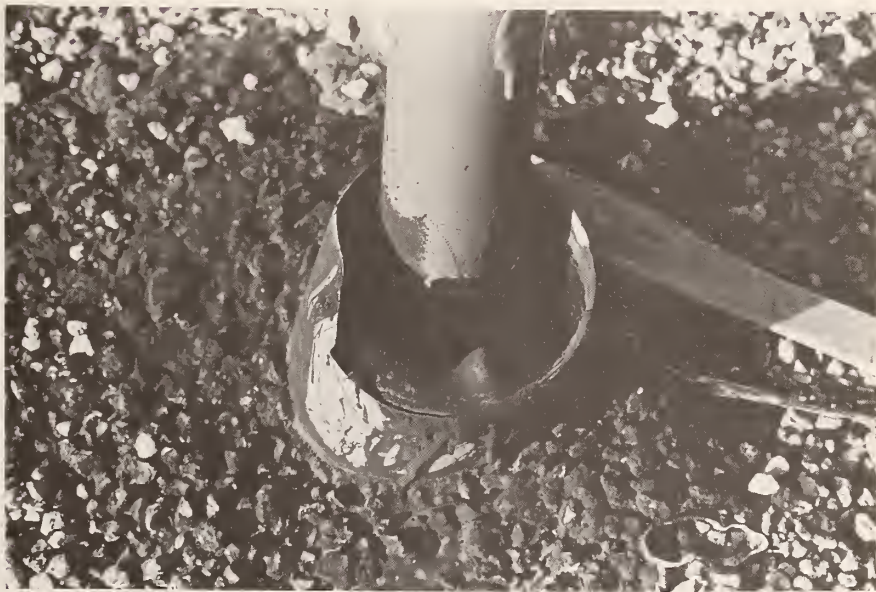
Figure C.10 Collector Support Column in a Tilted Pitch Pocket

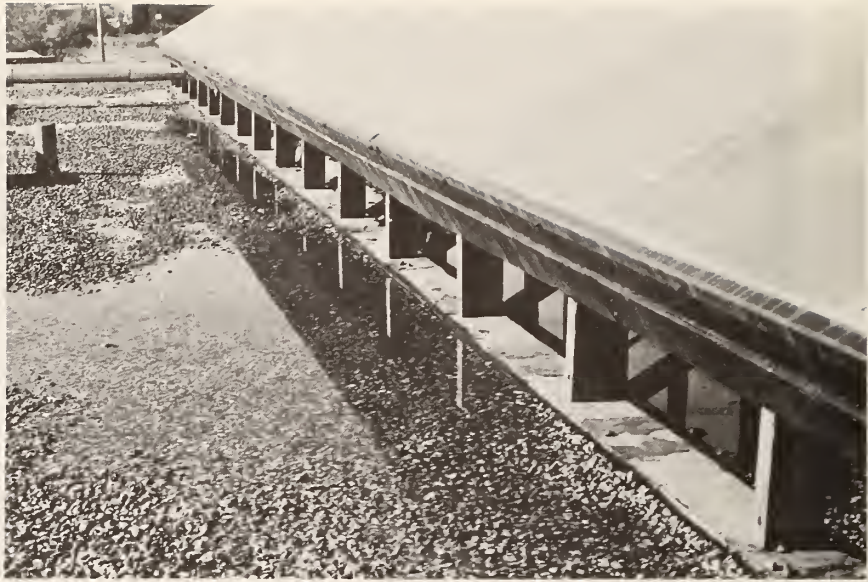
Figure C.11 Wooden Sleeper Mechanically Attached to Roof

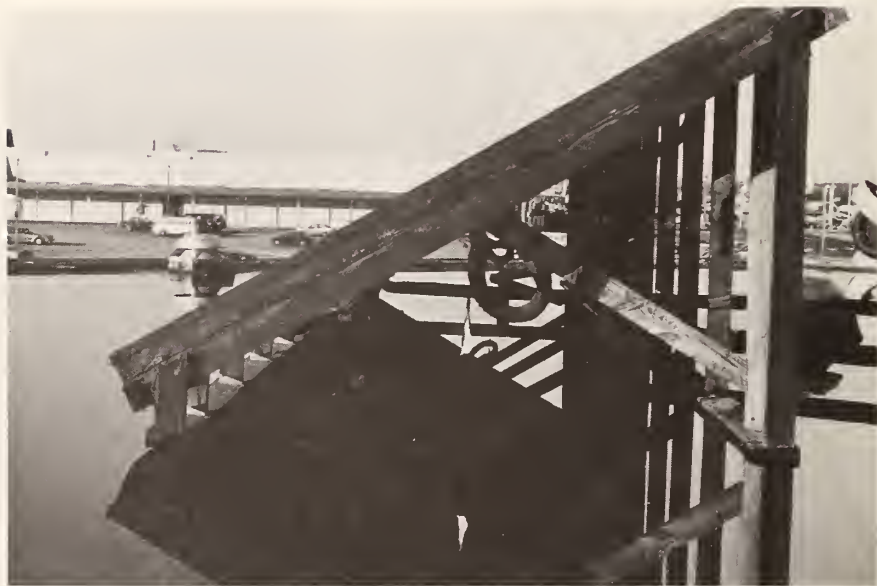
Figure C.12 Pooled Water Above the Bottom Surface of the Wooden Sleepers

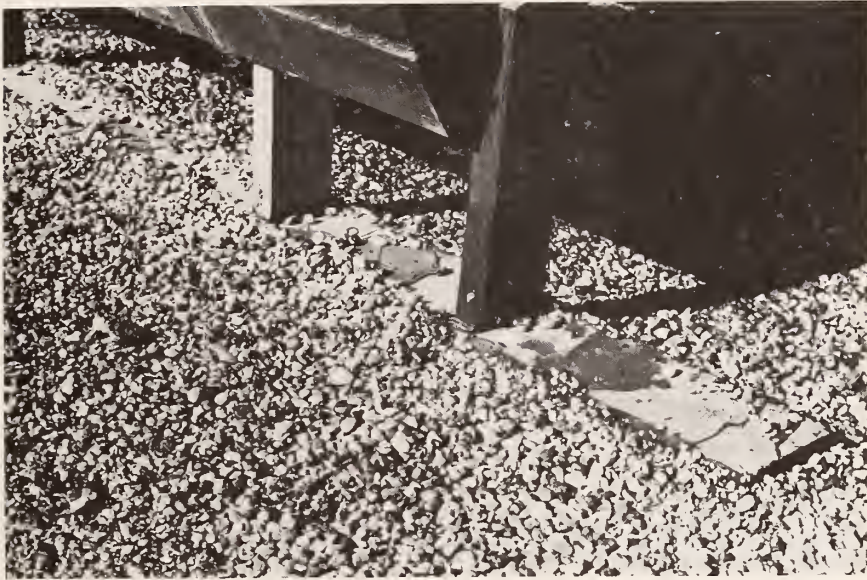
Figure C.13 Sleeper Which Had Sunk into Asphalt Flood Coat and Aggregate Surfacing

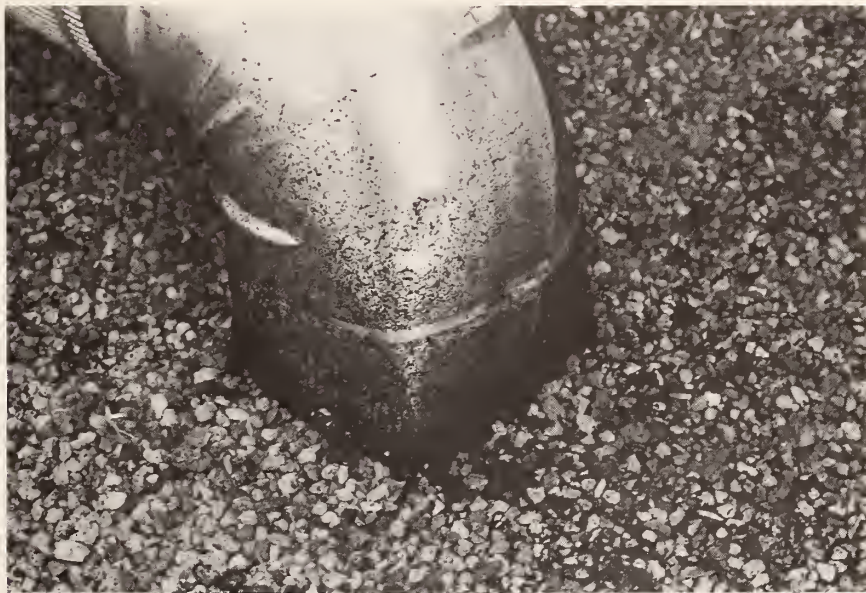
Figure C.14 Pipe Penetration for Which The Type of Flashing was Not Determined

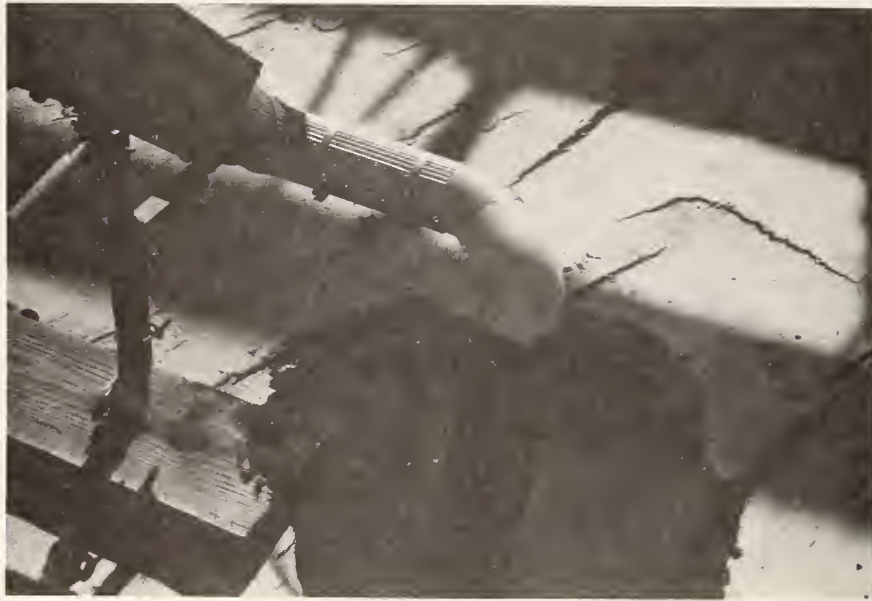
Figure C.15 Excessive Quantity of Asphalt Around Pipe Penetration With Undetermined Type of Flashing

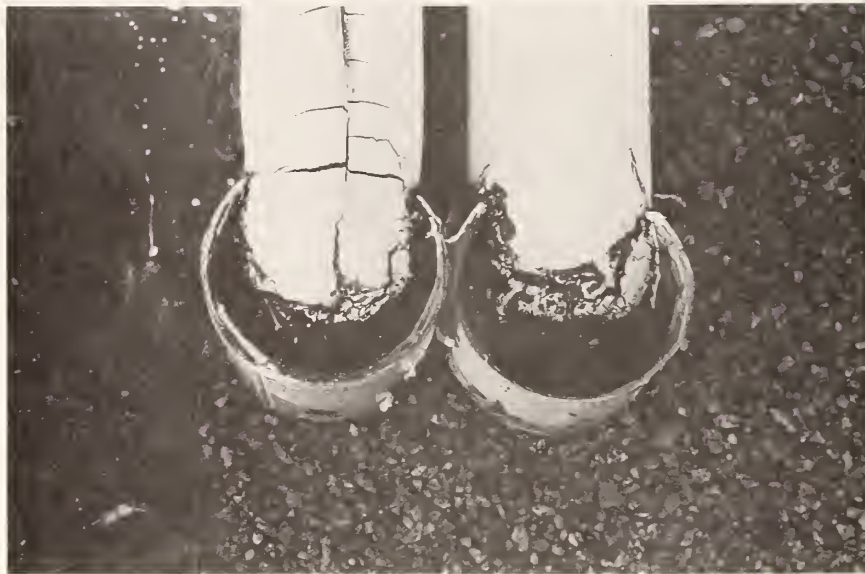
Figure C.16 Pitch Pockets for Pipe Penetrations

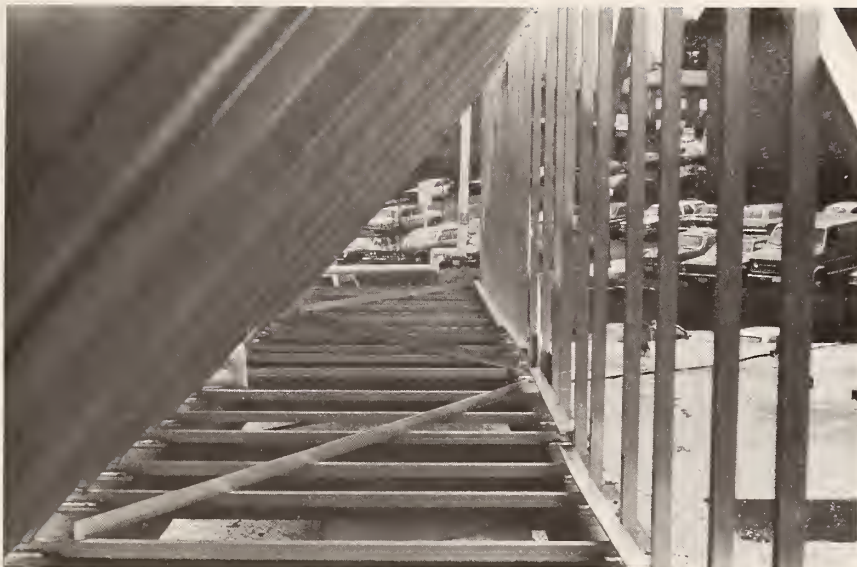
Figure C.17 Inadequate Clearance Between Steel Collector Frames and Roofing

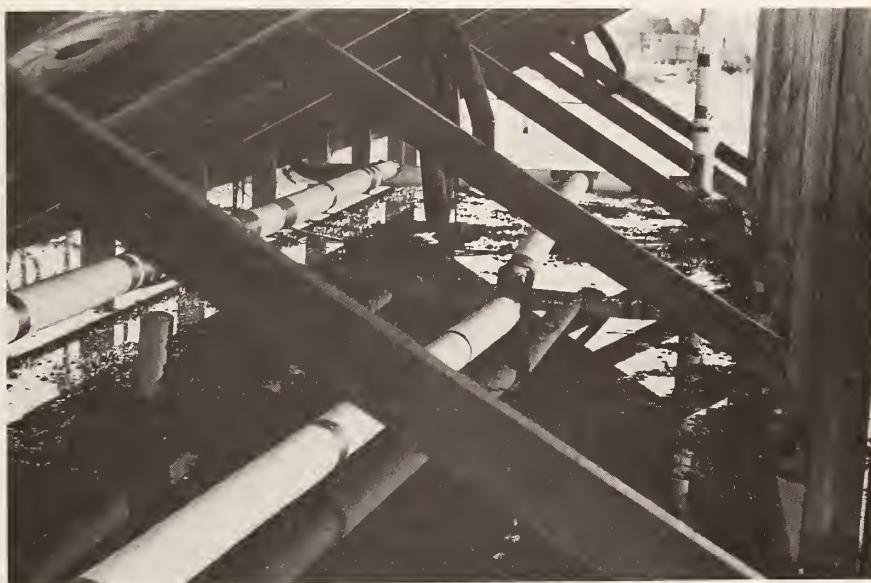
Figure C.18 Inadequate Clearance Between Wooden Collector Frames and Roofing

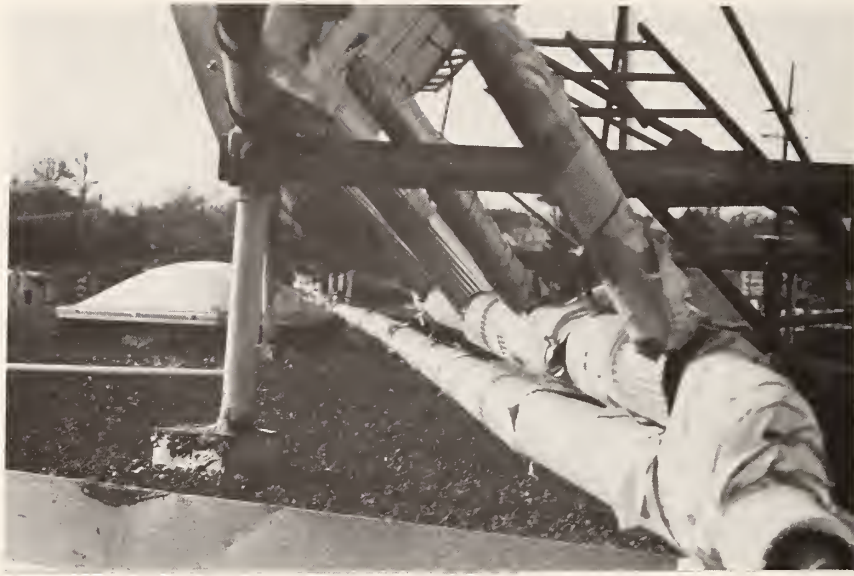
Figure C.19 Piping Located Close to Roof Surface

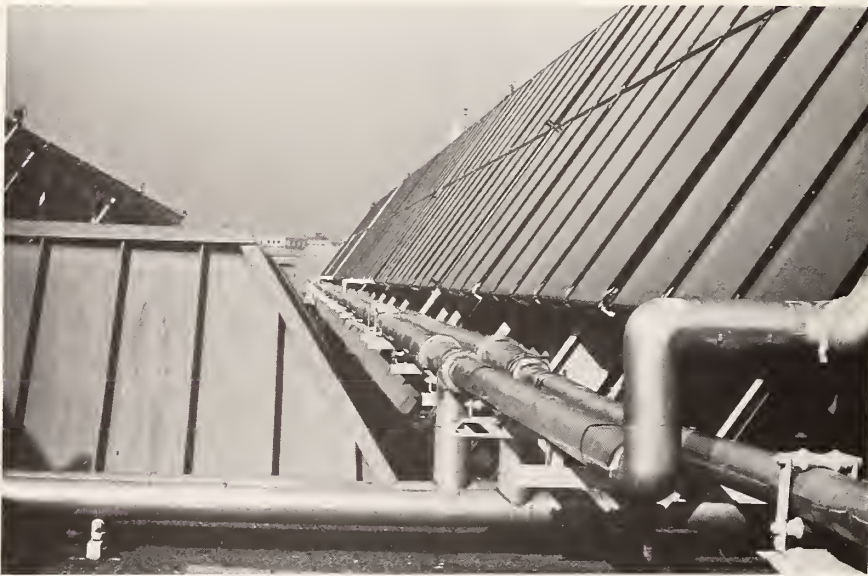
Figure C.20 Inadequate Clearance Between Front of Collector Array and a Mansard Style Roof Projection

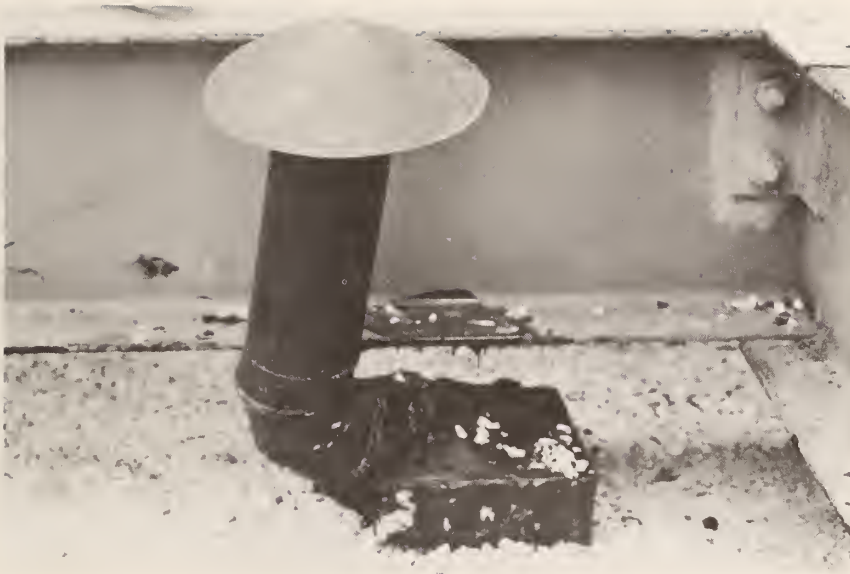
Figure C.21 Vent Pipe Modified to Allow for
Solar Collector Installation

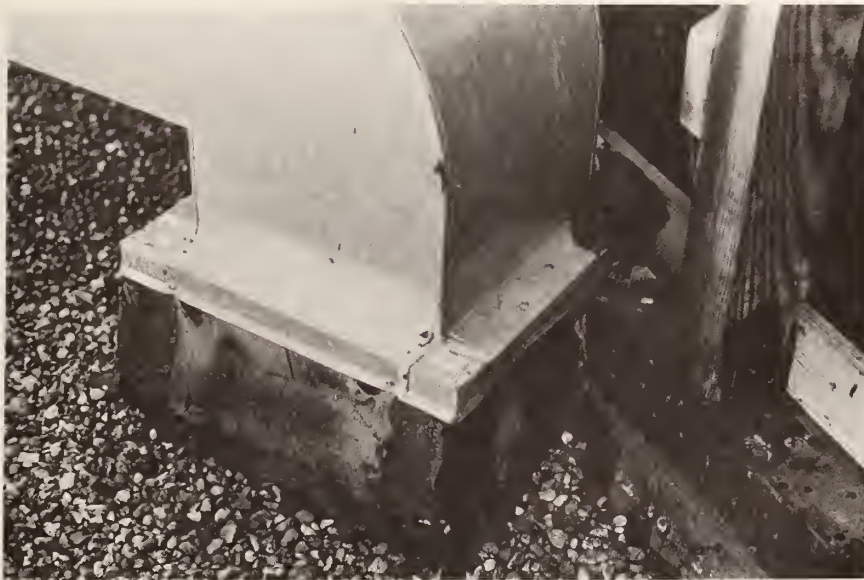
Figure 22. Modification of a Curb Supporting a Ventilator

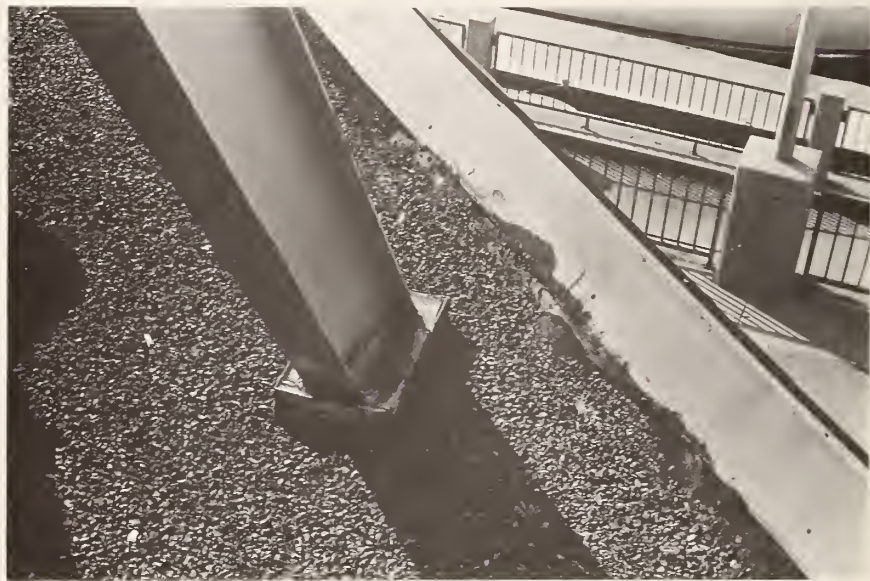
Figure C.24 Solar Penetration Adjacent to the Edge
of the Roof

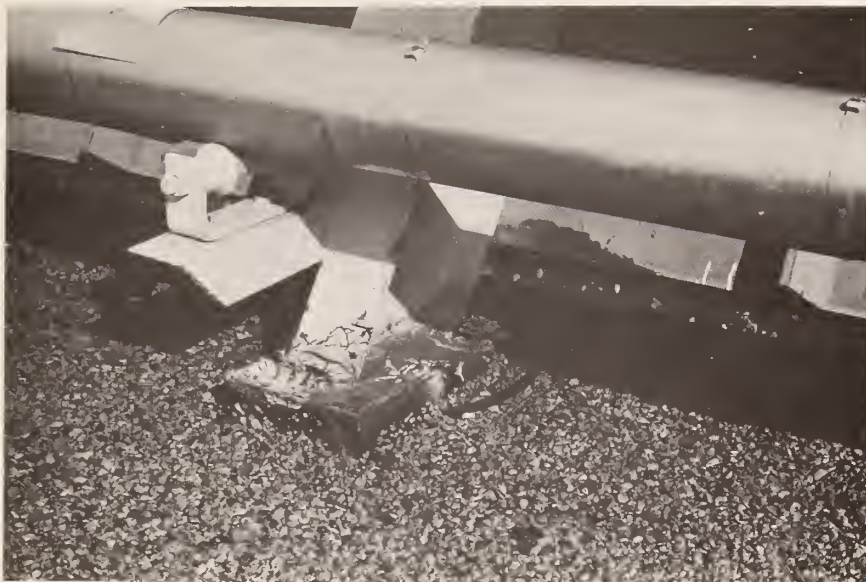
Figure C.25 Pipe Roller Support Attached to Collector Frame

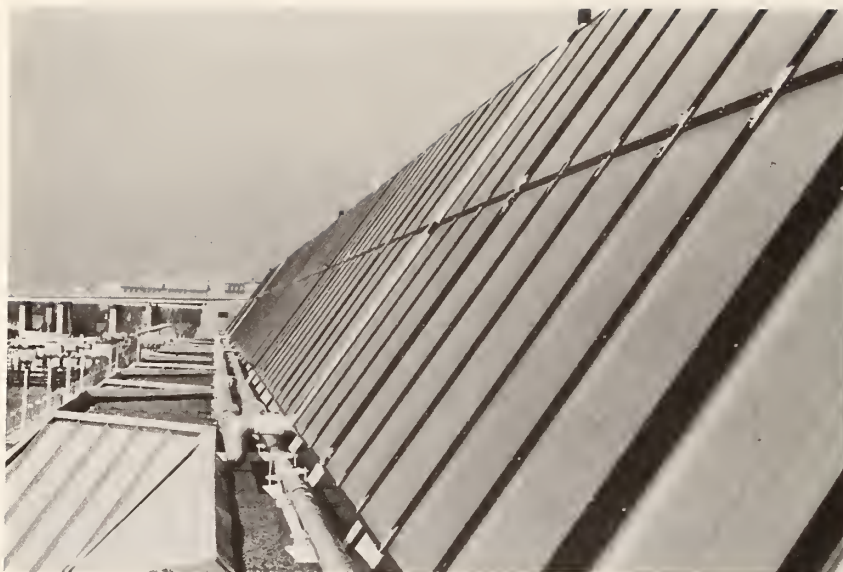
Figure C.27 Collector Array Installed Near Roof Edge

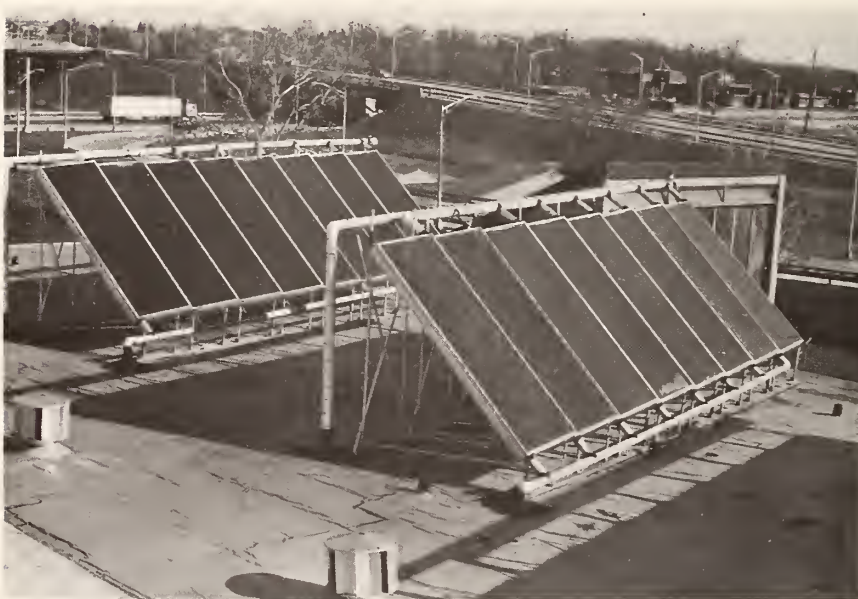
Figure C.28 Installation Having Adequate Access Around Collector Arrays

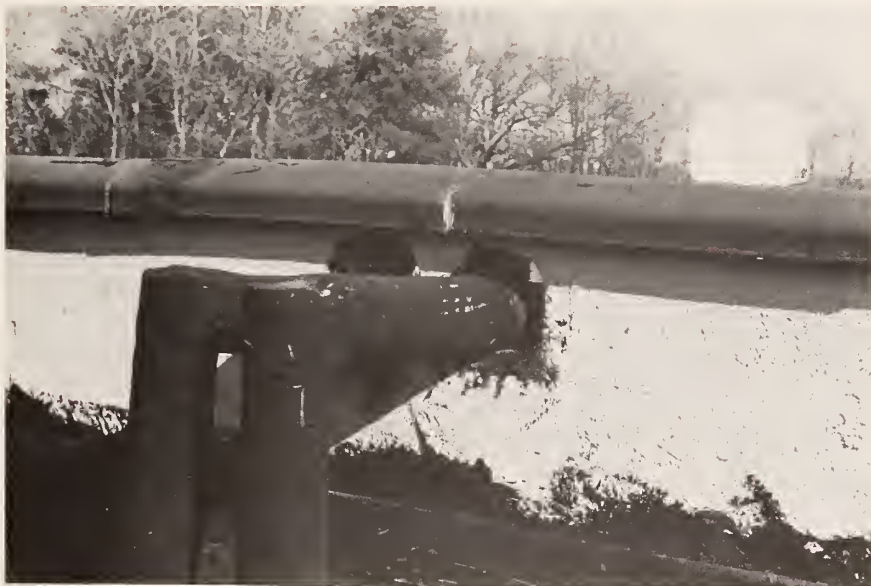
Figure C.29 Fire Wall Penetrated by Solar Piping

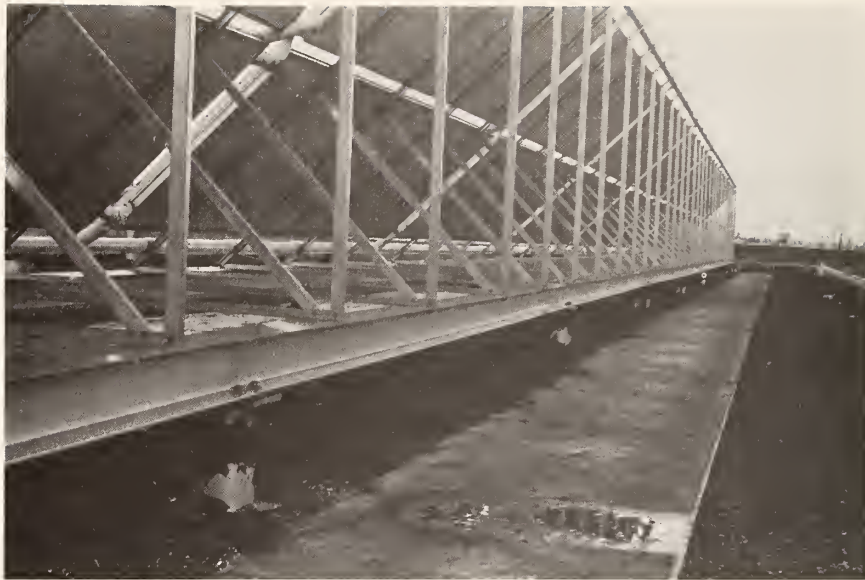
Figure C.31 Coated Felt Walkway on Roofing

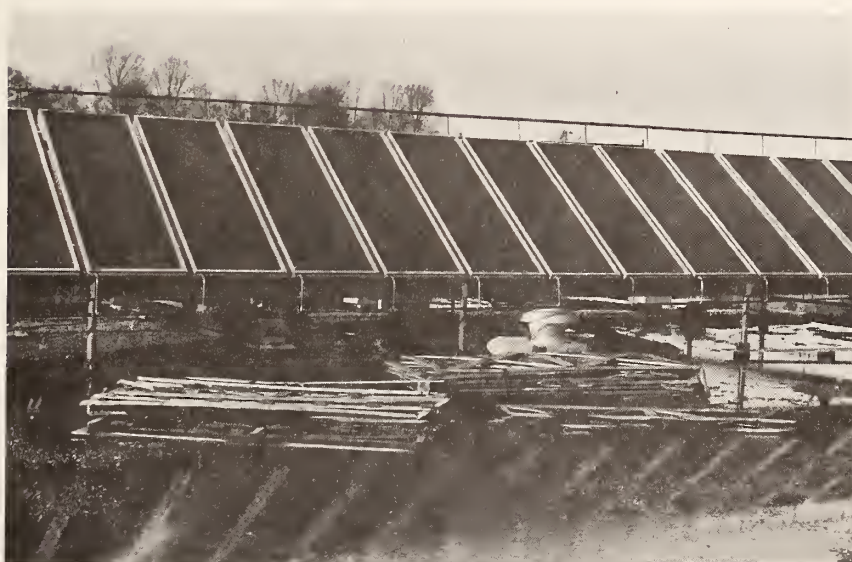
Figure C.34 Debris On Roof from Solar Installation
